Conservation Collier Initial Criteria Screening Report

Property Name: Blake – 9.54 acres
Folio Numbers: 00107640004

Staff Report Date: October 11, 2004
CCLAAC Approval Date:

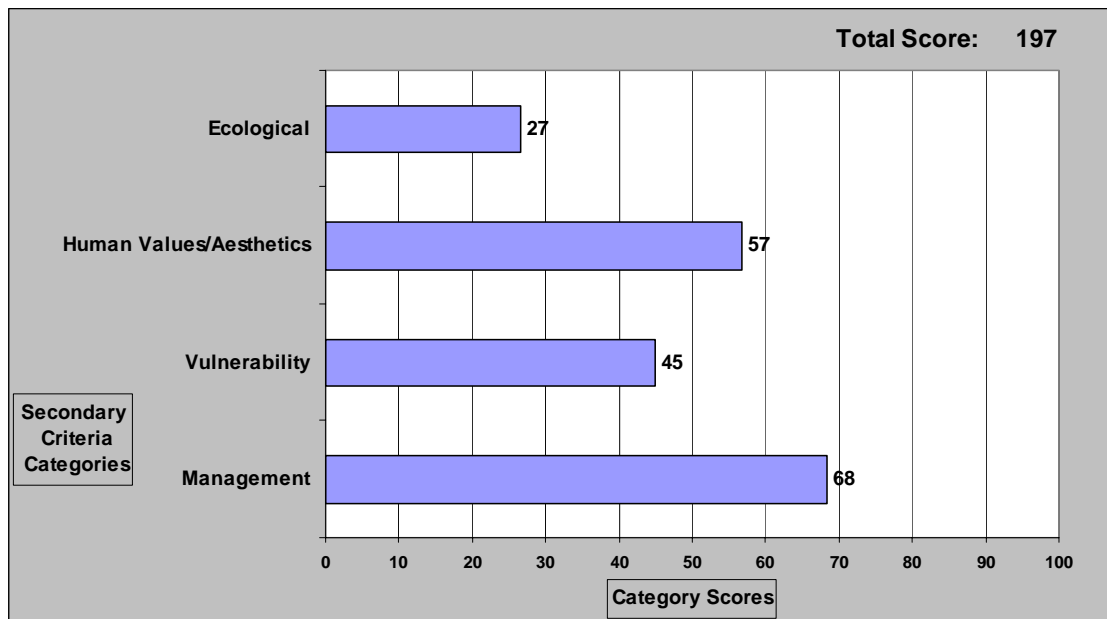
Figure 4. Secondary Screening Criteria Scoring

Ecological 27: This score was achieved because the property only contains one native plant community, and this community is not prioritized by program criteria as unique or endangered. The parcel did gain some points, because it contains wetlands (though the parcel may be wetter than historically was the case), has endangered plants, contributes to both aquifers and has high restoration potential.

Human Values/Aesthetics 57: This score was achieved because the site is accessible by an unpaved road and it would provide for land-based, natural resource-based recreation opportunities. Approximately $\frac{1}{4}$ of the property is visible from a public roadway.

Vulnerability 48: This parcel is zoned for agriculture with a mobile home overlay. This would allow for one single-family dwelling unit or mobile home every 5 acres. Because the parcel is slightly less than 10 acres, its development potential appears to be only one single-family residence, however, it could be totally cleared for farming.

Management 68: The parcel received this score because management would be somewhat minimal to moderate. Very few exotics are present on the property, although the neighboring properties do contain a seed source. The old berm in the southwest corner may need to be removed and trails would need to be maintained. Use of prescribed fire as a management tool would be beneficial and appears to be a possibility as there are a few surrounding residential properties, although neighbors have not been contacted to ask. Old farm equipment has been abandoned on the property, and construction materials have also been dumped. Initial management actions would include the removal of this debris.

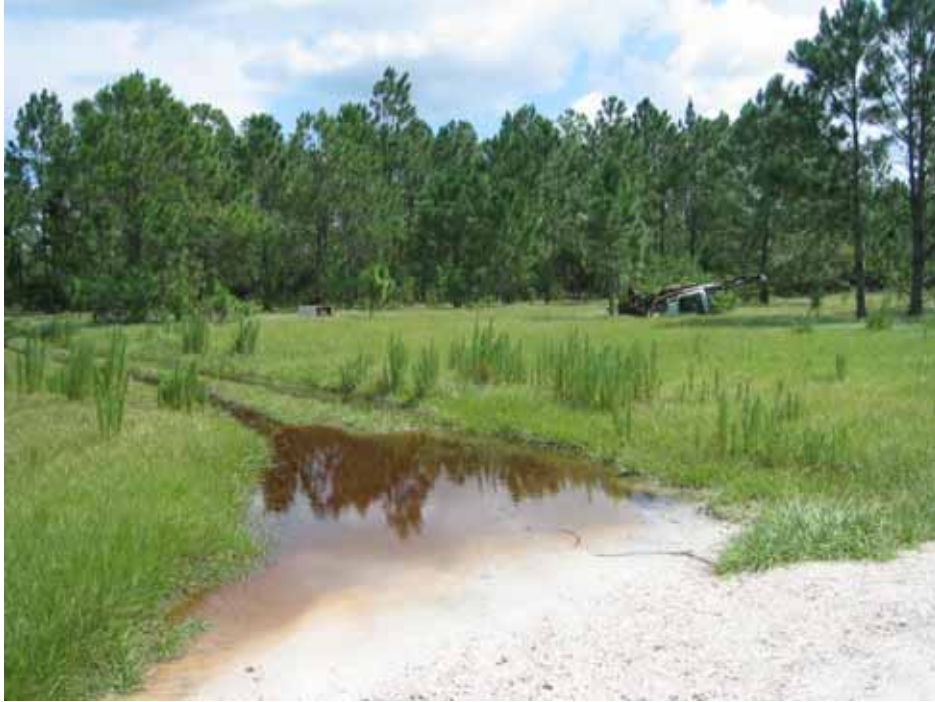
Photo 1. Entrance from Wild Turkey Dr. showing old farm field and some of the abandoned farm equipment – most which is along the berm line or just inside the property along the main trail

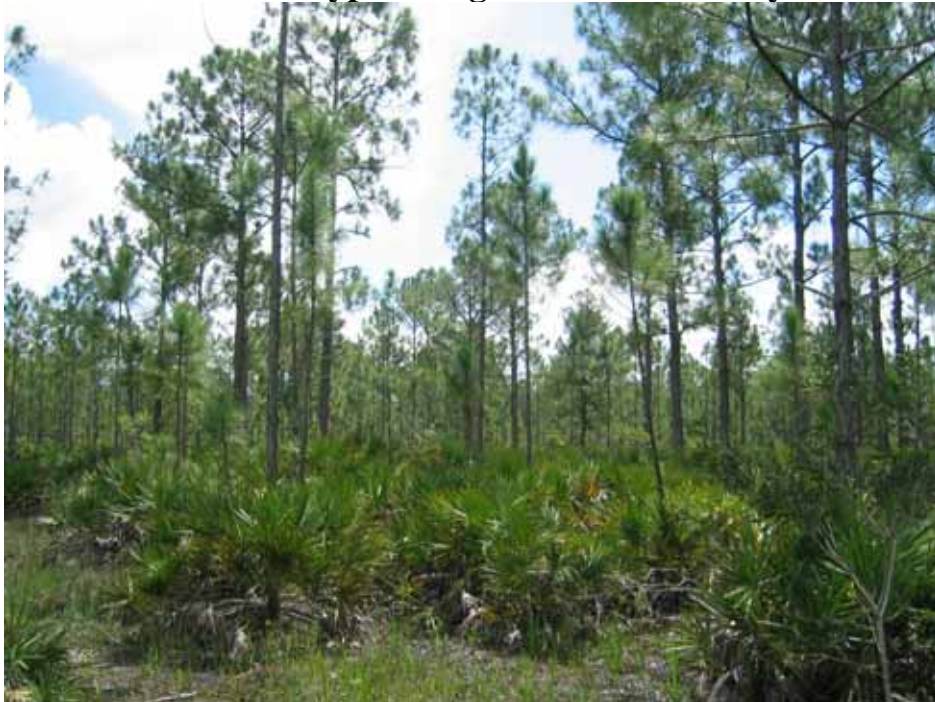
Photo 2. Pine flatwoods – typical vegetation community

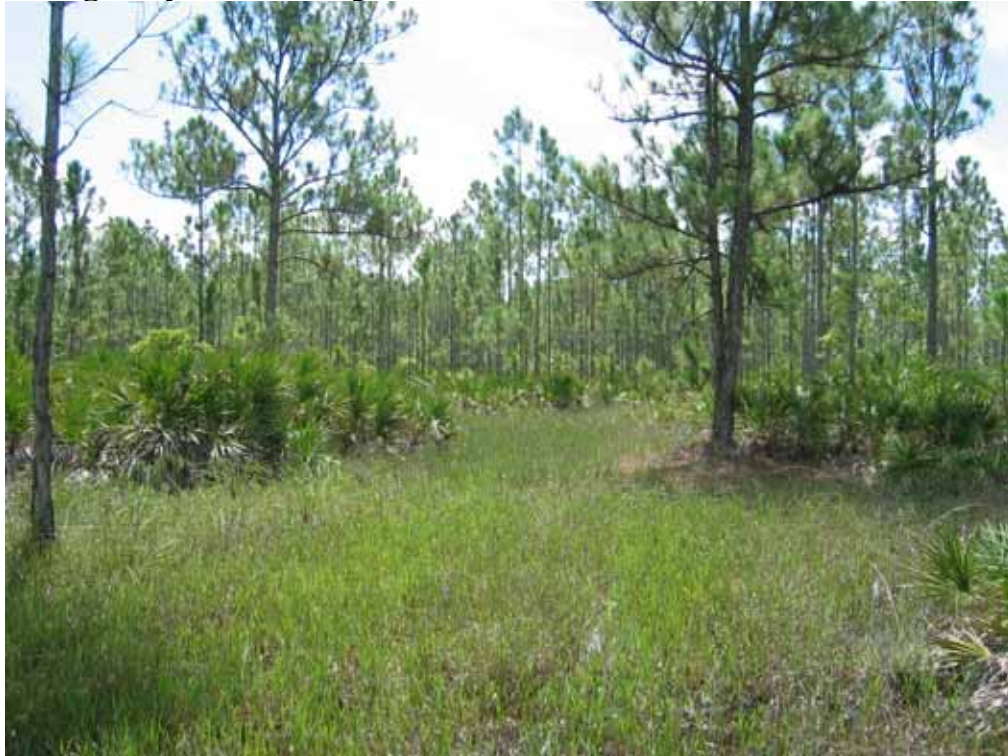
Photo 3. grassy area with ponded surface water

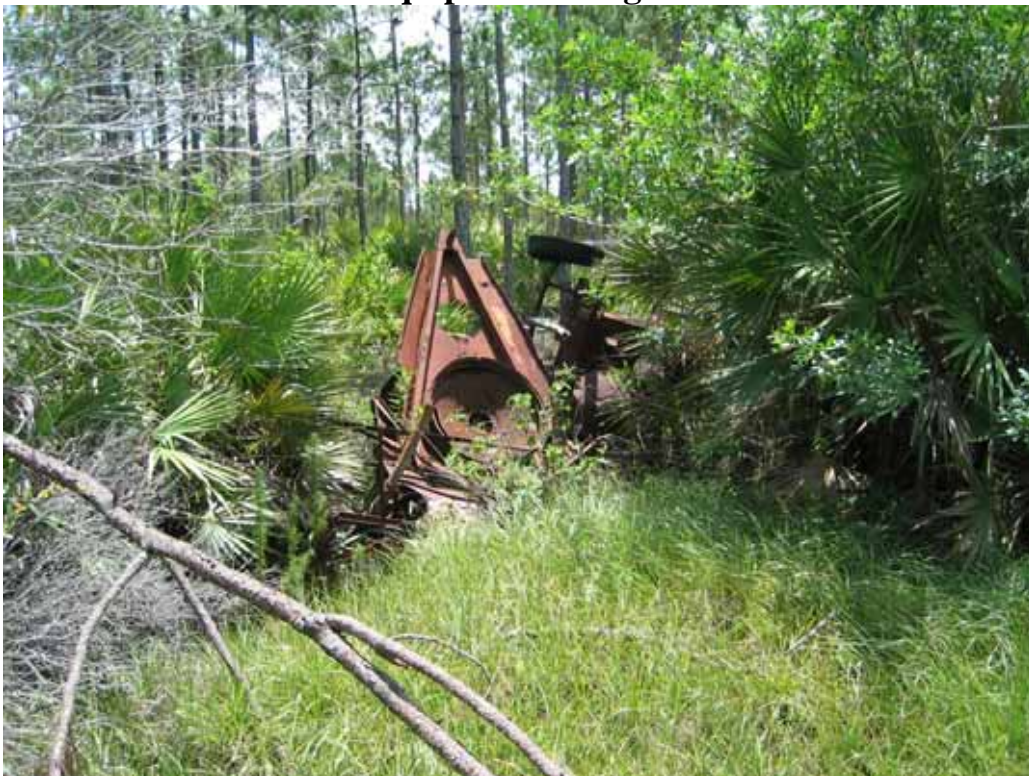
Photo 4. Abandoned farm equipment along berm

4. Add 20 points if the maintenance by another entity is likely	20		
5. Subtract 10 points if chronic dumping or trespass issues exist	-10	-10	old farm equipment abandoned property and dumping of construction materials noted

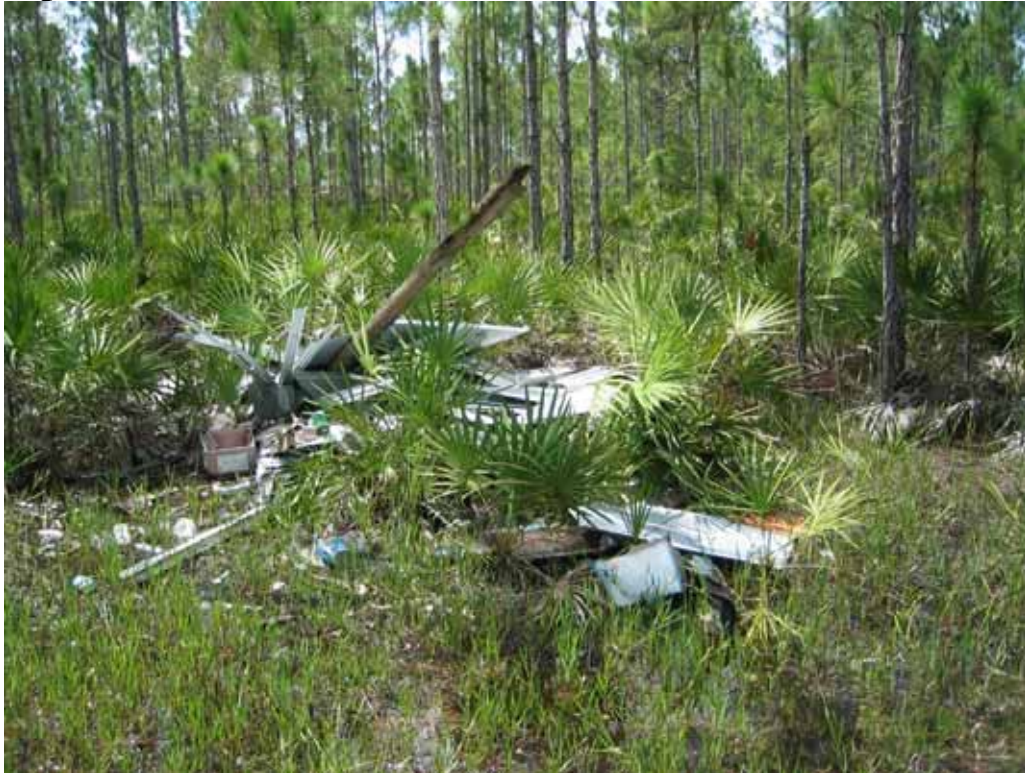
Photo 5. Dumped roofing material on the interior – ponded surface water present

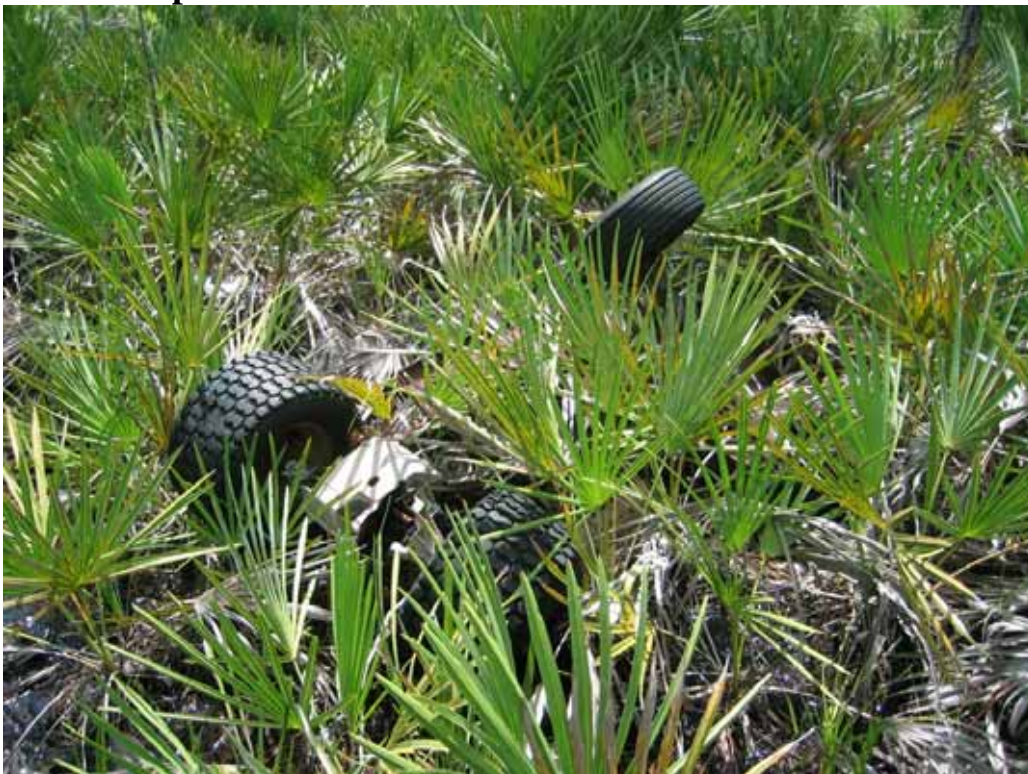
Photo 6. Dumped trash in interior

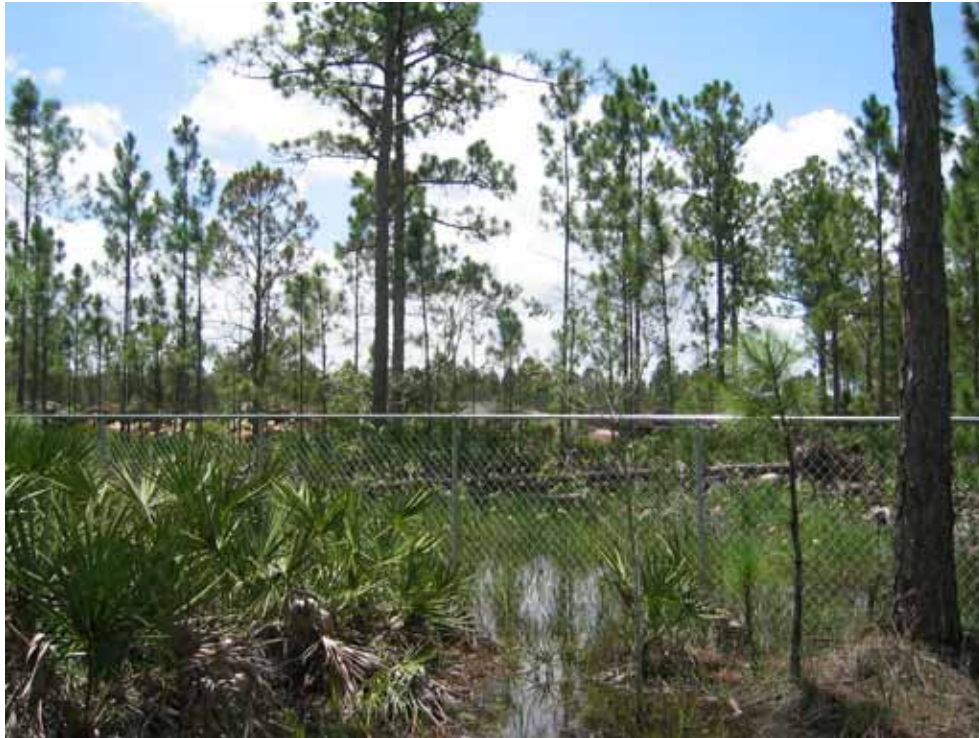
Photo 7. Fence along north boundary in area where ponded water observed over most of the surface up to approx. 1 foot deep.
